Servicing and Training

The Daimler Dingo Scout Car– Design & Development
Fighting Vehicles Project – Part Aa2
www.daimler-fighting-vehicles.co.uk

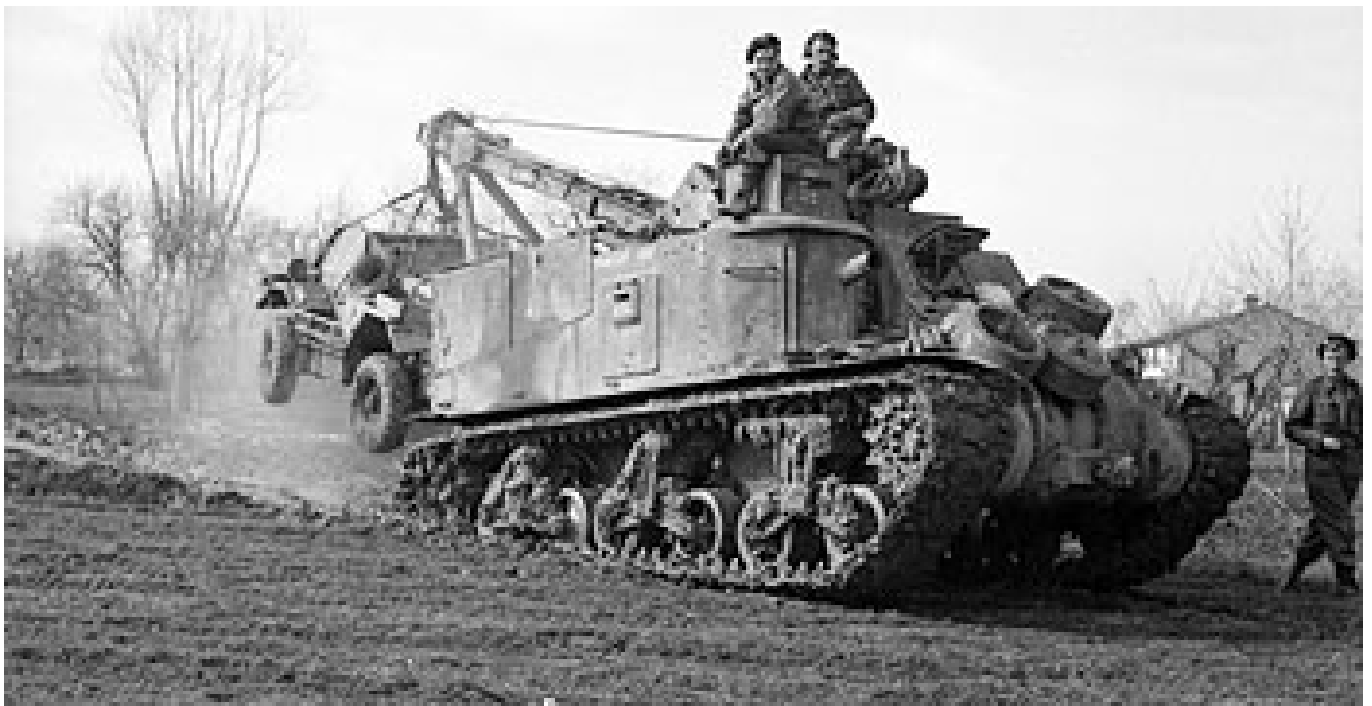
Photographer: Lambert (Sgt) of No 2 Army Film & Photographic Unit
Description: A Grant ARV of the New Zealand Division lifts a Daimler scout car, which had become bogged down in the mud near Faenza, 7 February 1945.

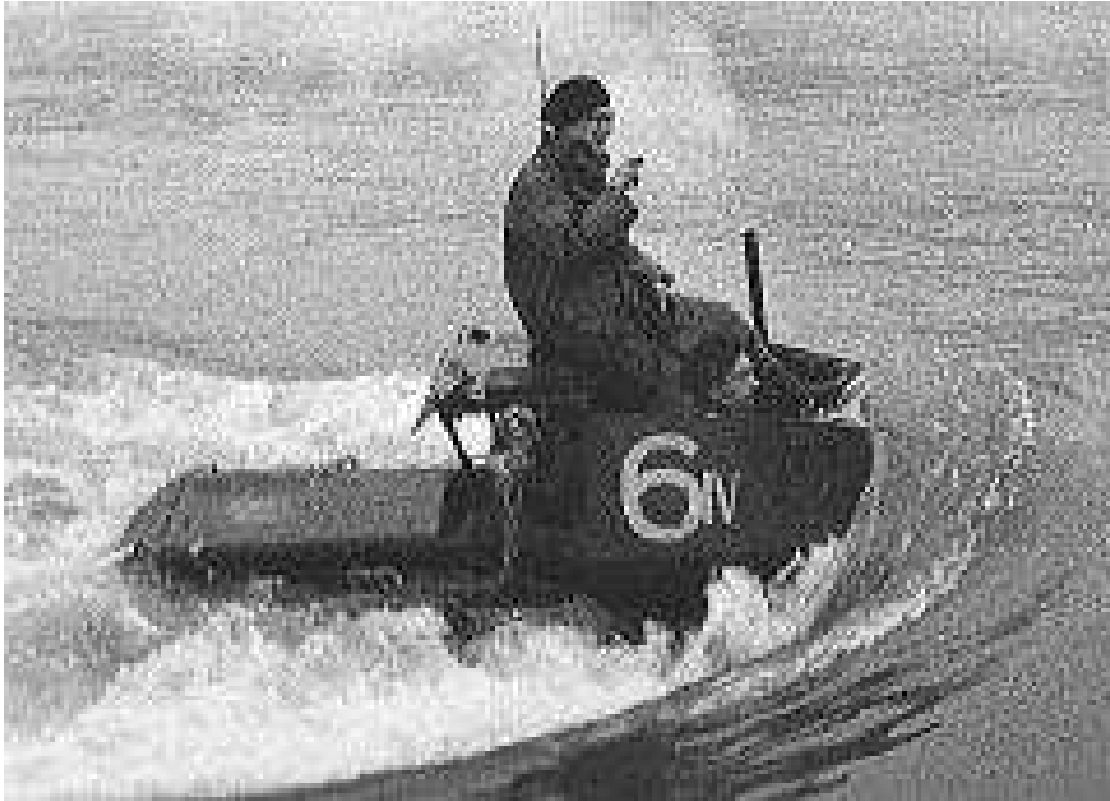
Photo Courtesy of the Tank Museum photo No. 4201/A/5
Waterproofing and fording trials and training, probably held in the sea of Weymouth

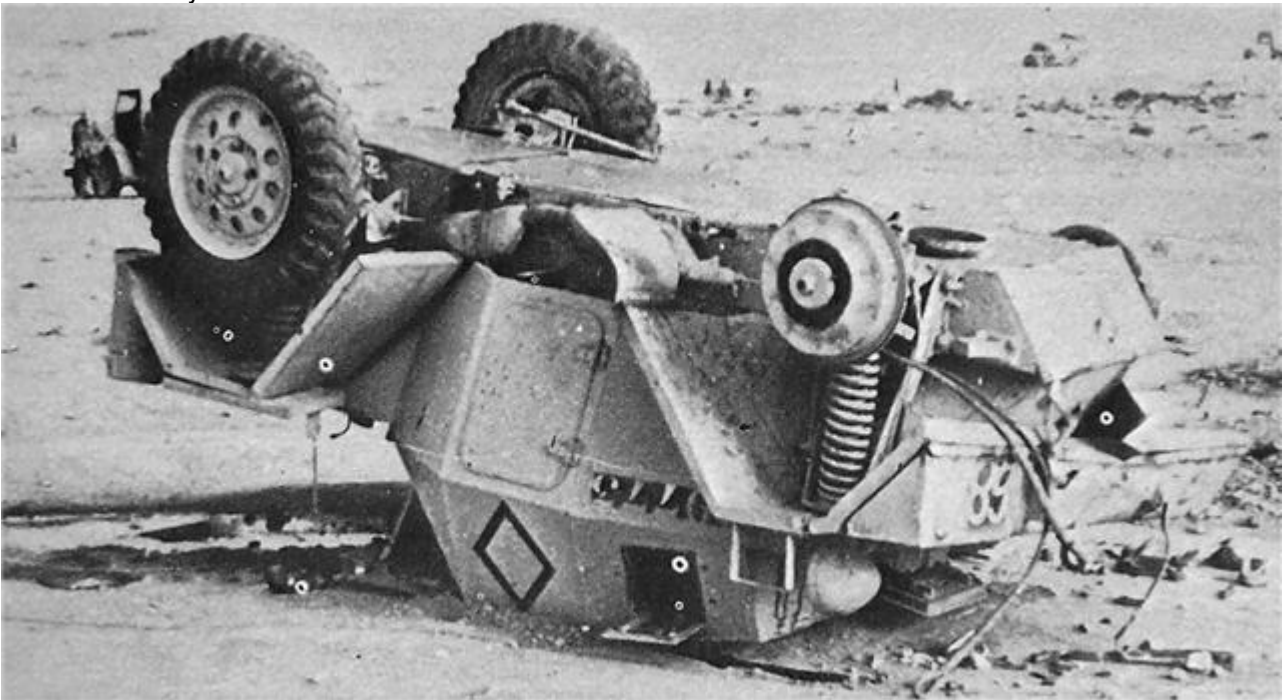
Description: Yet another mined scout car (F9773) somewhere in North Africa

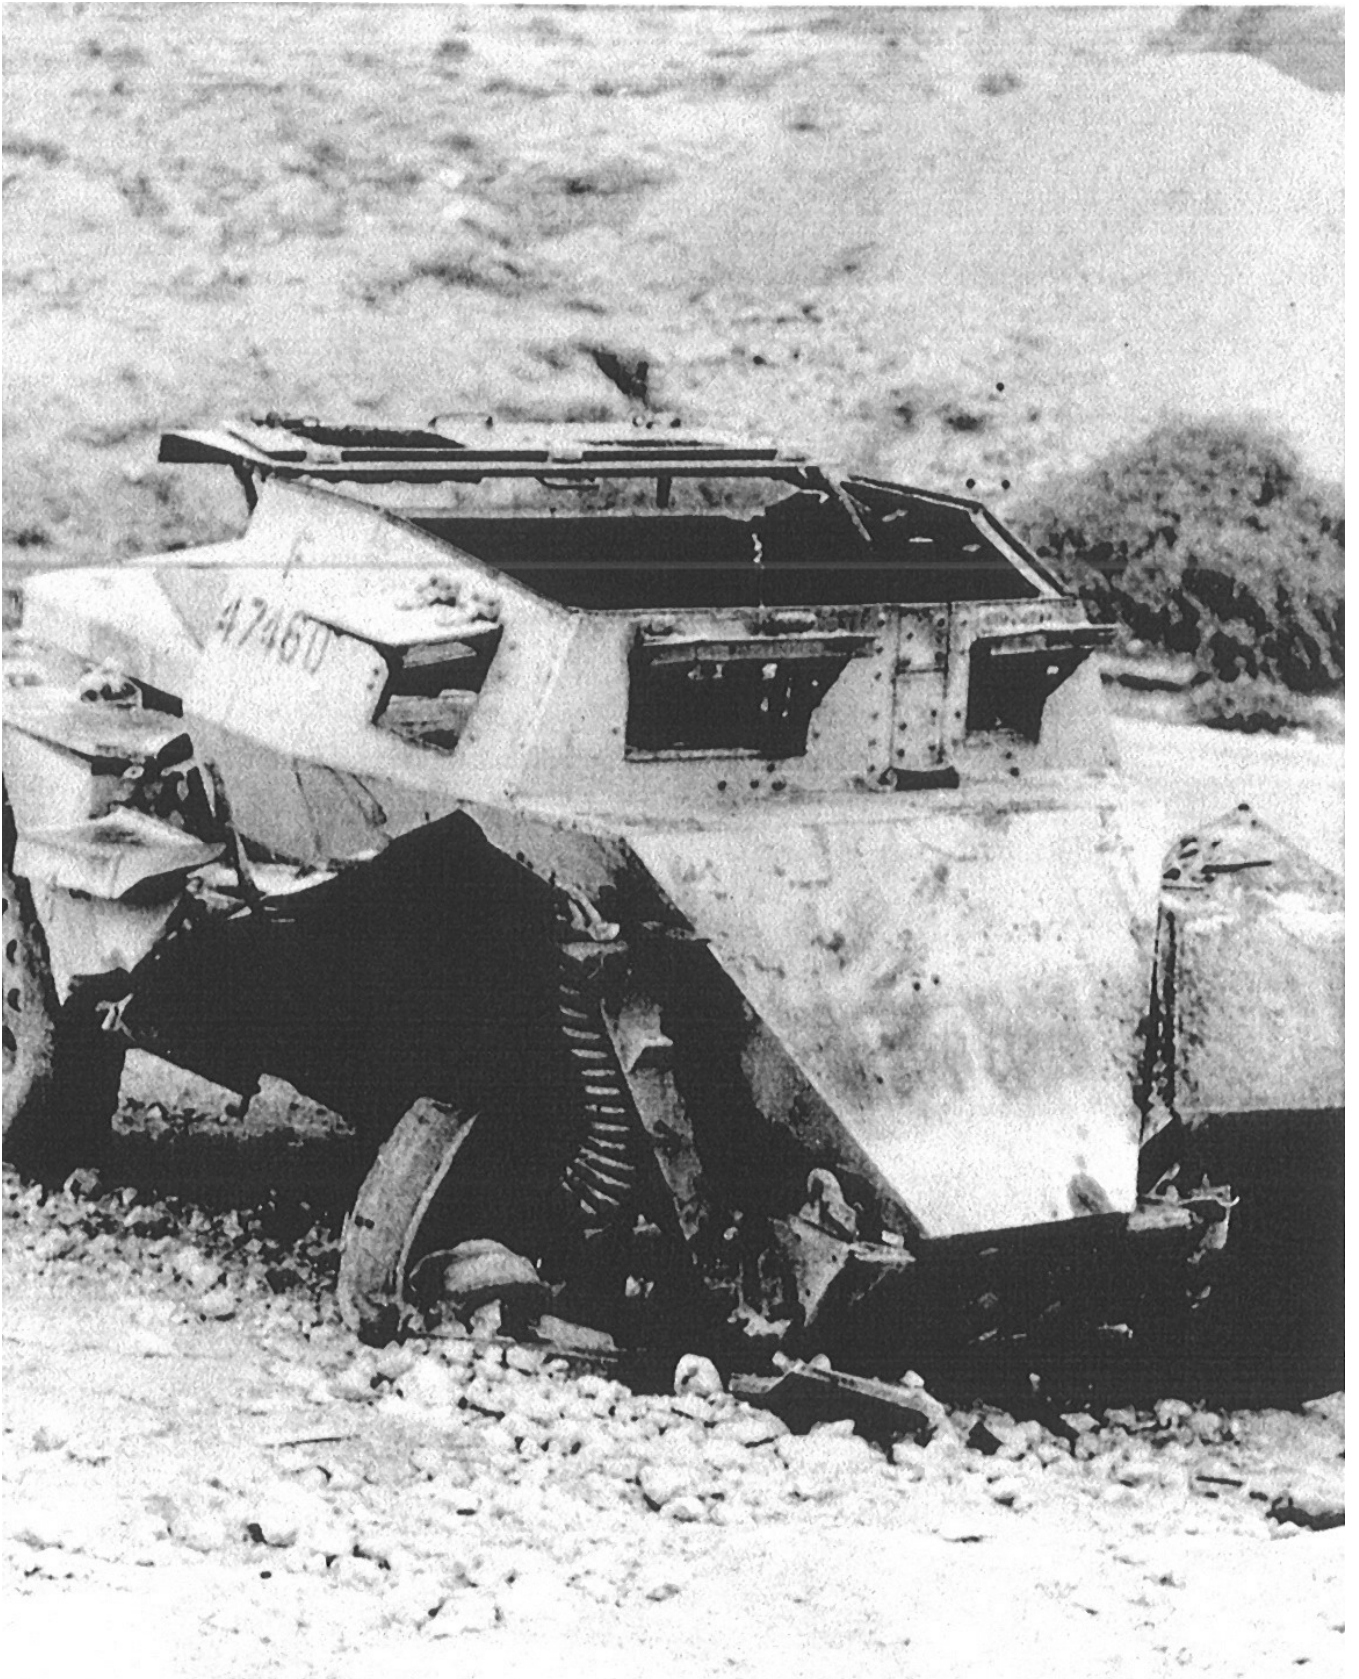
Description This Dingo (F47460) has run over a land mine in the North African Campaign, entirely removing the front bin, most of the wing and severely twisting the chassis and cracking the armoured plate at the back of the cabin to the rear of the fuel tank.

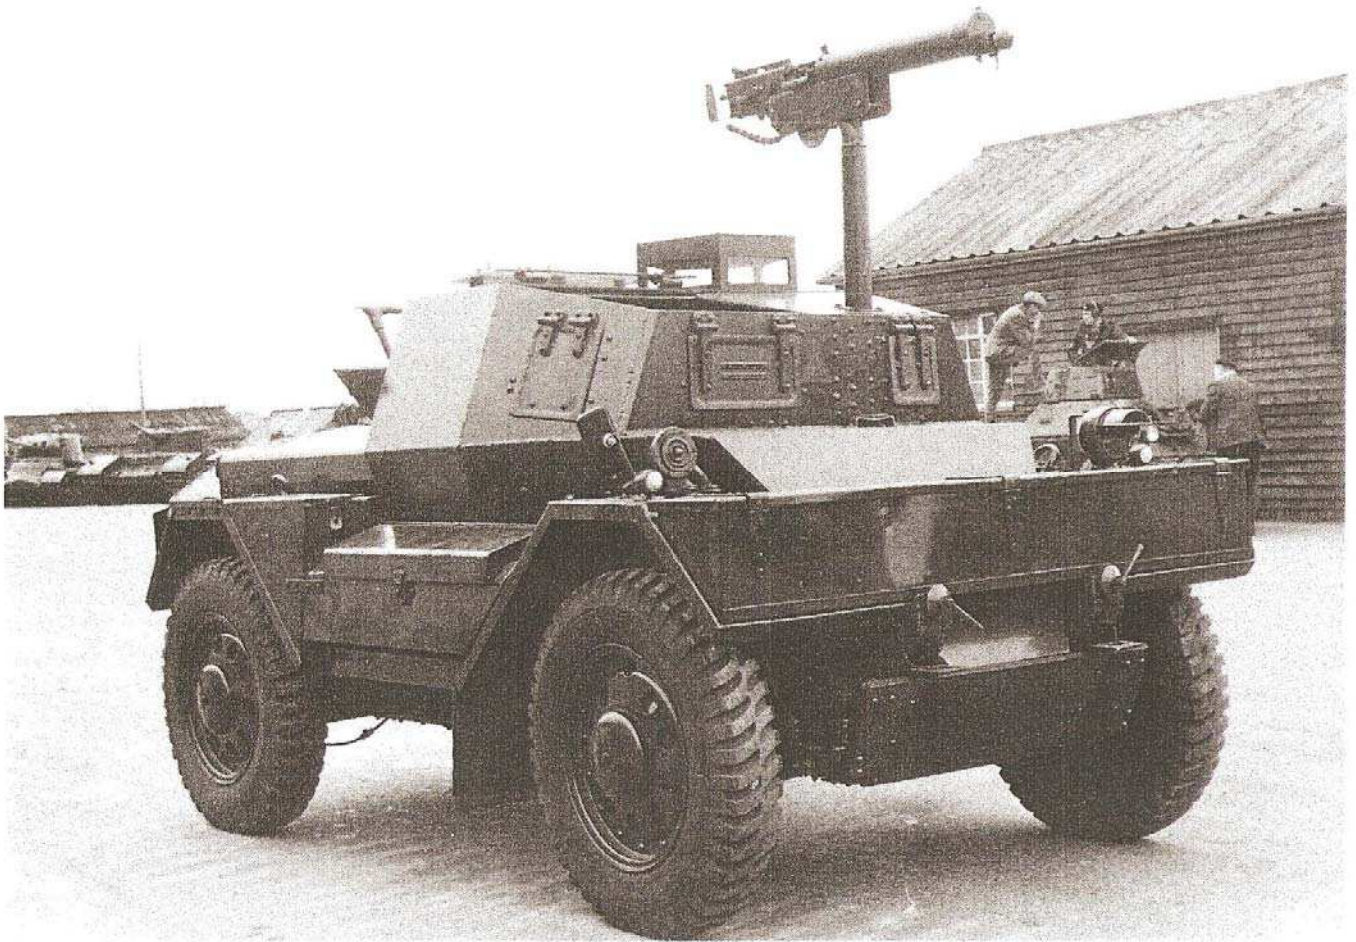
Description: In the 1950's trials were held to fit more effective armament and also increase the level of protection; this was necessitated by the use of the vehicles in enclosed locations such as the Jungles of Malaya.

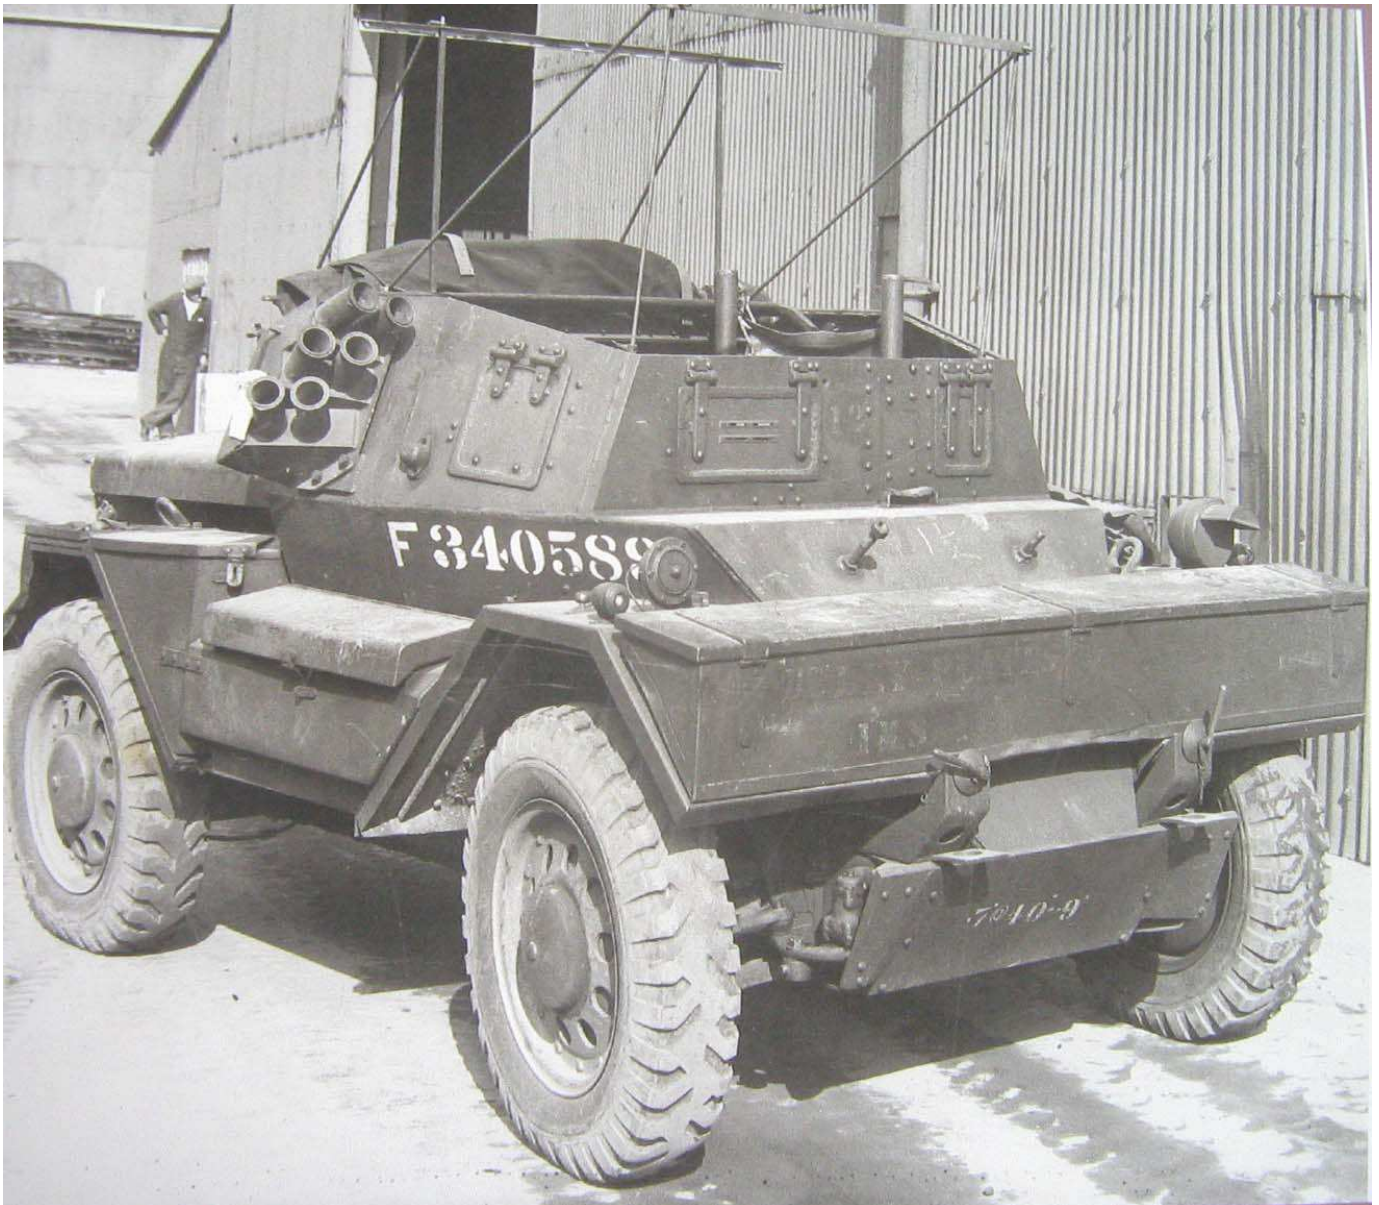
Description: this photo of Dingo F340589 shows a strange framework above the turret, possibly for the addition of wading screens but the assembly does not look to be robust enough to resist much water pressure? Also odd are the two studs welded to the frontal armour above the front bin.

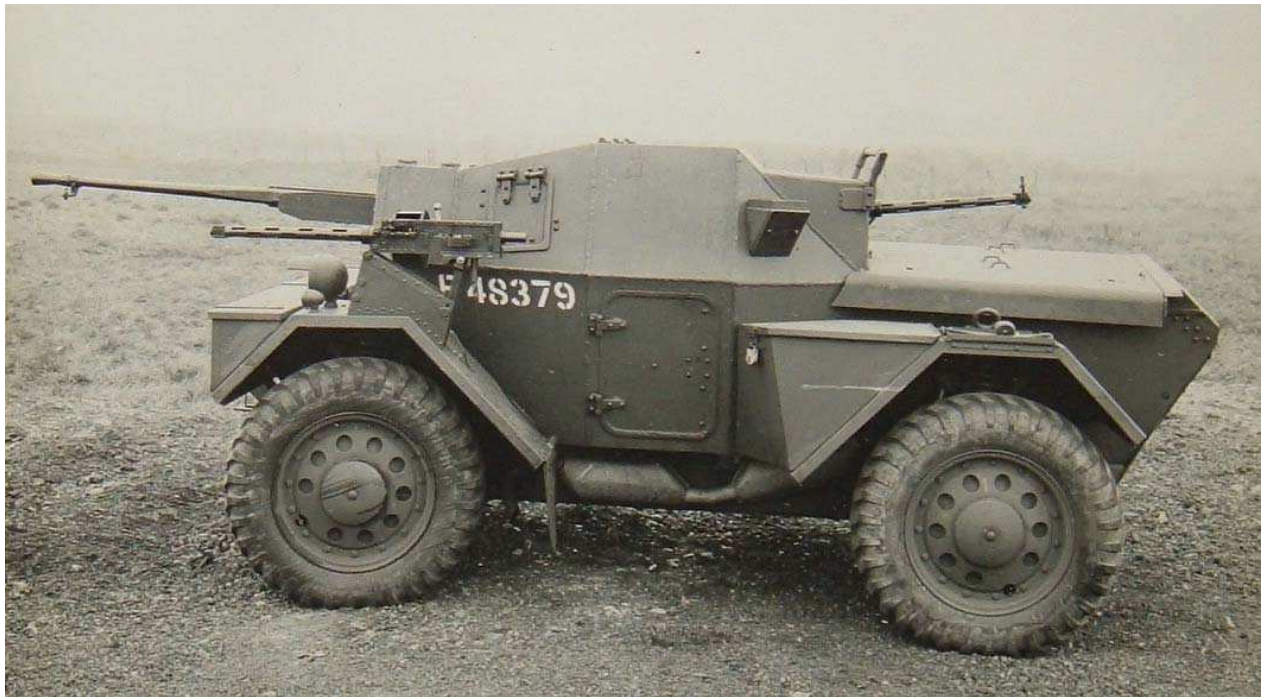
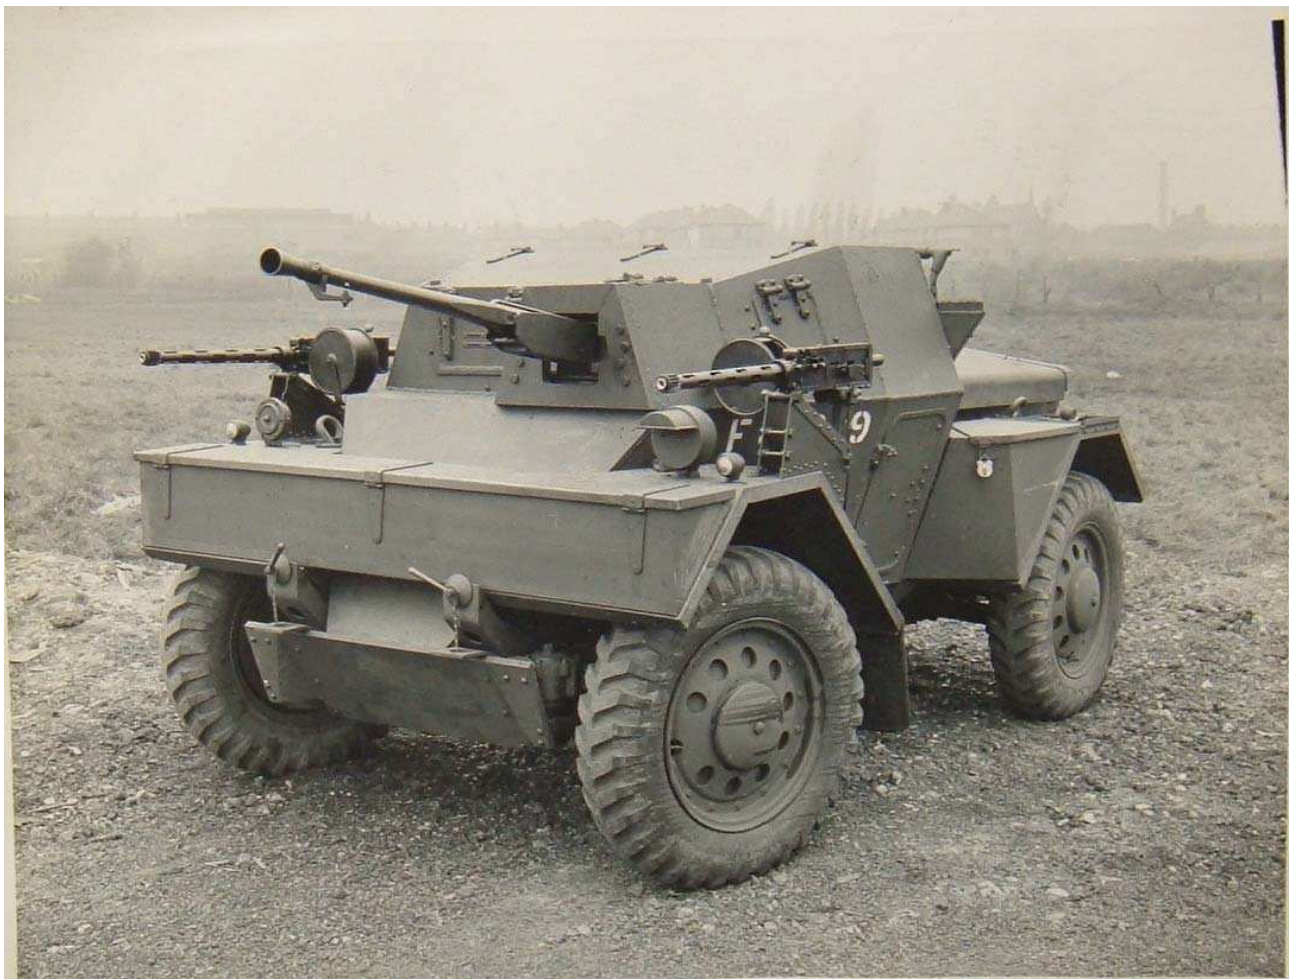
Description: What is presumably the most heavily armed Dingo (F48379) ever created.
Specification, twin aircraft 303 sponson mounted browning MGs, single 303 browning MG to the rear and
a .5 BESA heavy MG as main armament!
Date Unknown.

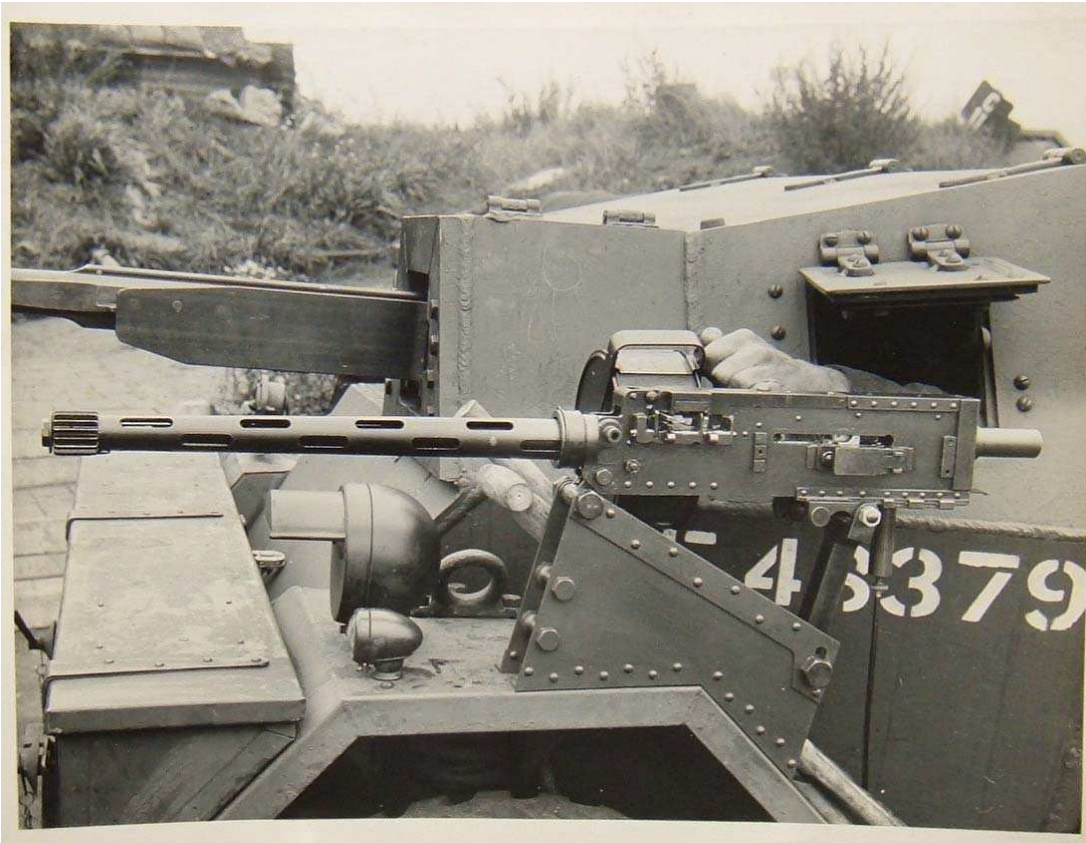
Description: Note the joy stick from a spitfire on the floor between the drivers legs than contains the firing triggers for the twin brownings.
