R.A.R.D.E. MEMORANDUM (B) 66/63

Trials to assess the lethality of a 76 mm HESH shell  
against armoured personnel carriers

R. Beresford

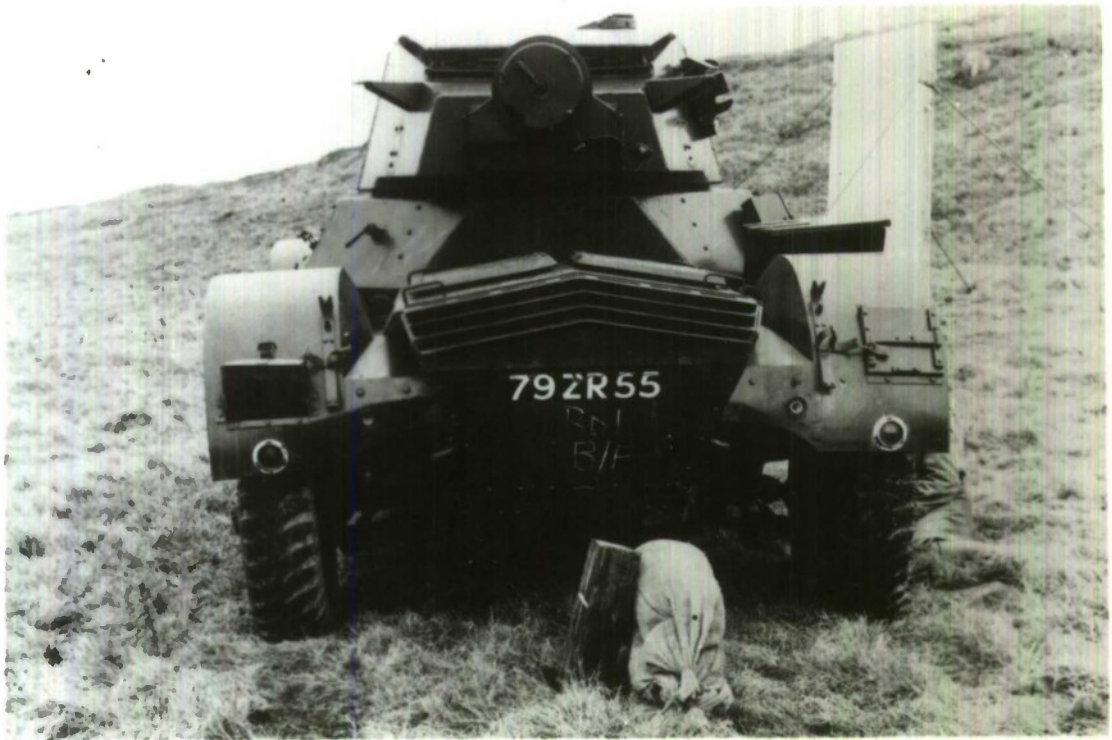
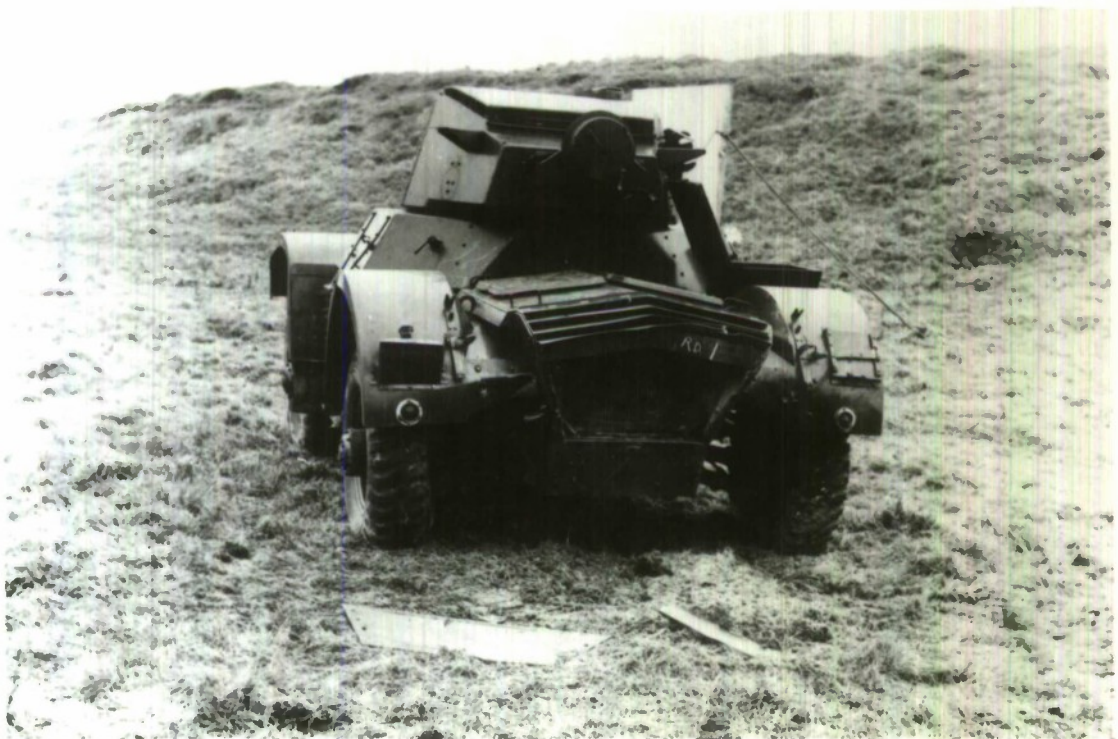
FIG. I NEAR MISS CLOSE TO THE ENGINE COMPARTMENT

- (a) The Engine Compartment (Figure 1). The outer plate (14 mm) was blown off but there was little damage either from fragments or blast except for an unimportant oil leak. The effect on Mobility was considered to be nil.
- (b) Vehicle Front (Figure 2). Damage from many large fragments was apparent. Both tyres on the vehicle R.H.S. were punctured and a hydraulic leak was started. The Mobility loss was assessed at 25%.
- (c) Wheels (Figure 3). The frame of the wheel was undamaged but large fragments stuck in the tyre casing would possibly have caused a puncture before the car had moved very far. The loss of Mobility was considered to be 5%.

DAIMLER ARMoured CAR TARGET		
Round No.	Location of strike	Damage
1.	Wood block 2 ft. from engine.	Rear plate blown off but otherwise little damage. Effect on Mobility = zero.

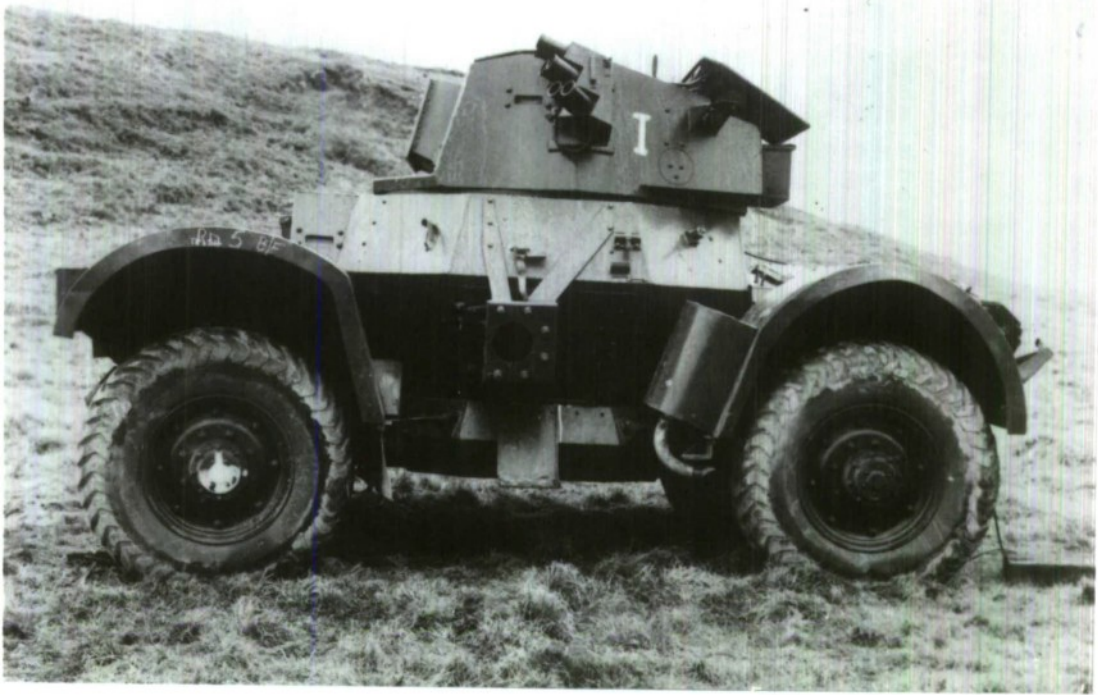
FIG. 5 DIRECT HIT ON WHEEL HUB

- (a) Wheel Hub (Figure 5). The wheel centre was totally destroyed and the tyre severely damaged.

Mobility loss = 95%.

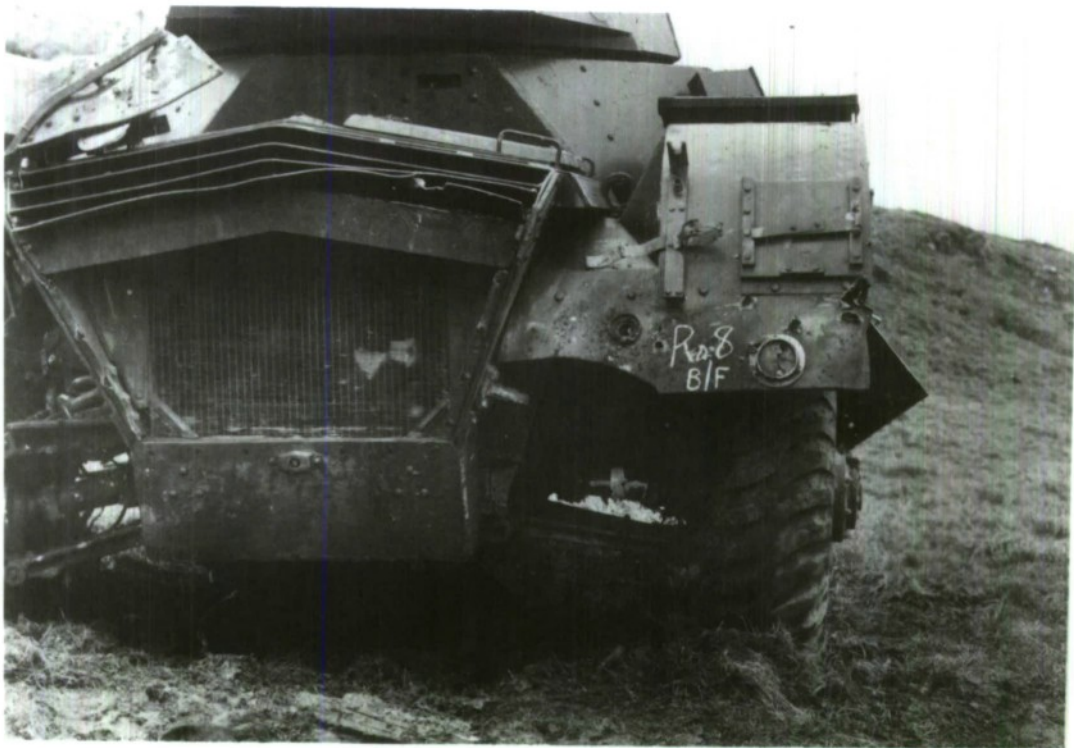
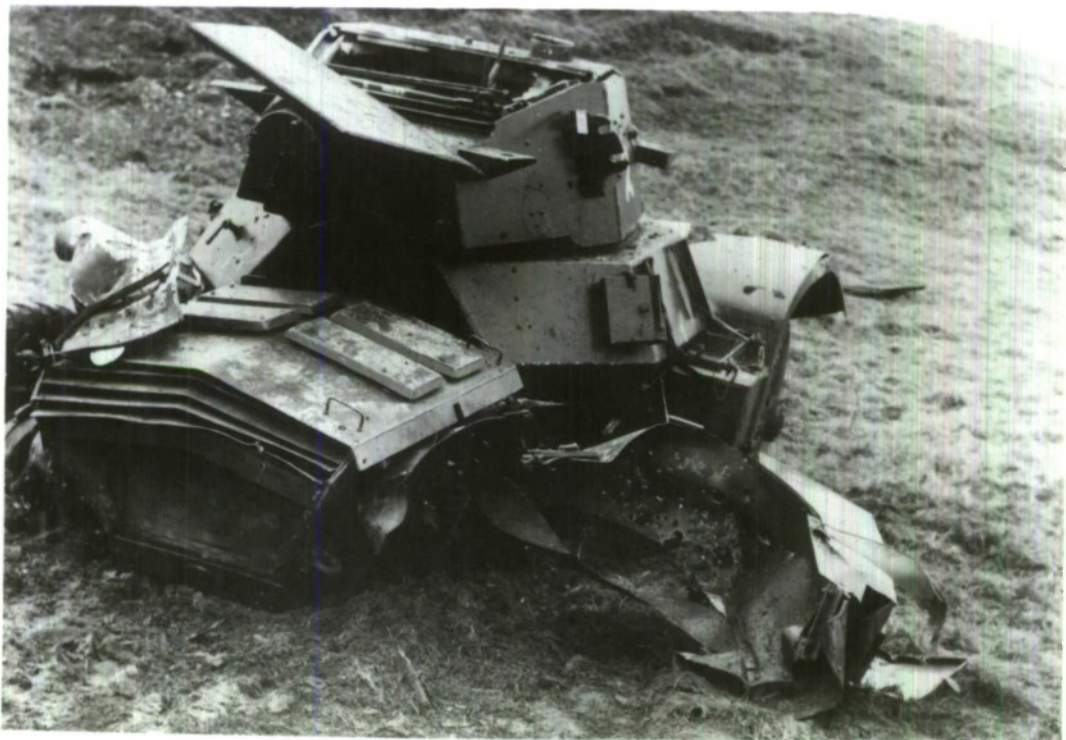
FIG. 7 DIRECT HIT ON SUSPENSION

- (c) Suspension (Figure 7). The wheel was blown off and the suspension wrecked on the side concerned. No crew damage was apparent from blast and fragments but the effects of concussion would have been large.

Mobility loss = 100%.

6.	Tyre in plane of wheel.	Wheel and tyre destroyed. Severe damage to suspension. Mobility loss = 95%
7.	Suspension	Wheel blowoff and suspension wrecked. Mobility loss = 100%

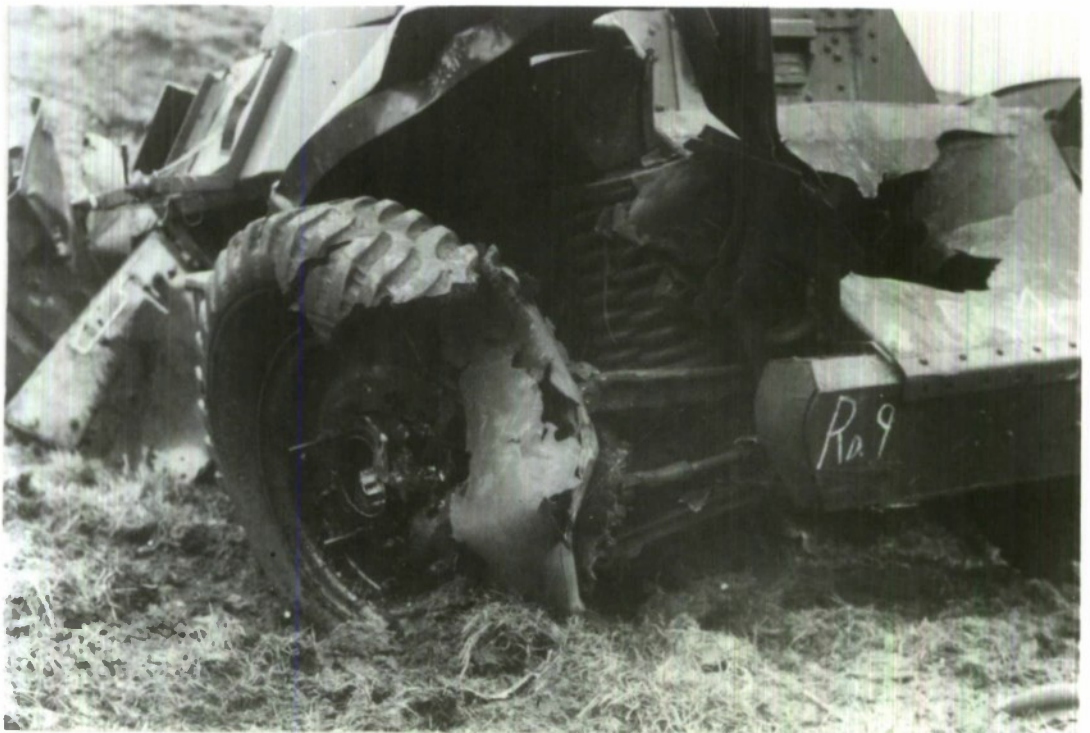
FIG. 8 DIRECT HIT ON WHEEL HUB

- (d) Wheel Hub at 45° to Wheel Plane (Figure 8). The wheel and tyre were severely damaged and removed from the suspension which was also damaged.

Loss of Mobility = 100%.

8.	Wheel hub at 45° to wheel plane.	Wheel and tyre damaged and blown off. Suspension wrecked. Mobility loss = 100%
9.	0° into front plate (7 mm armour).	Round penetrated and burst inside car.

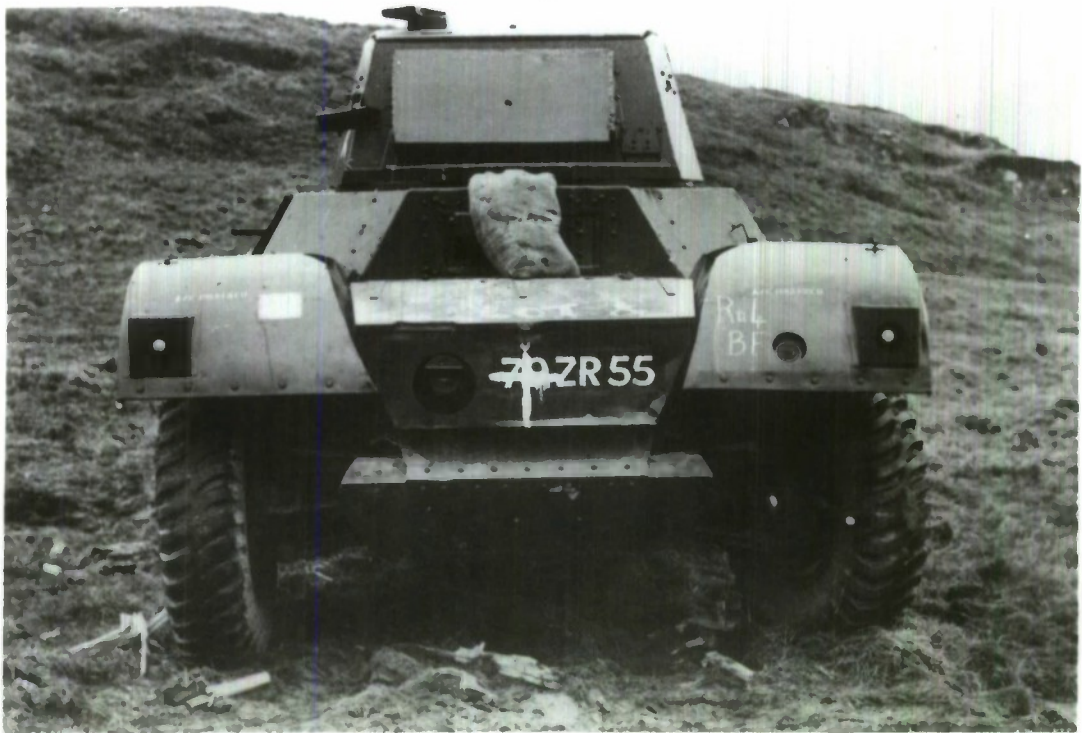
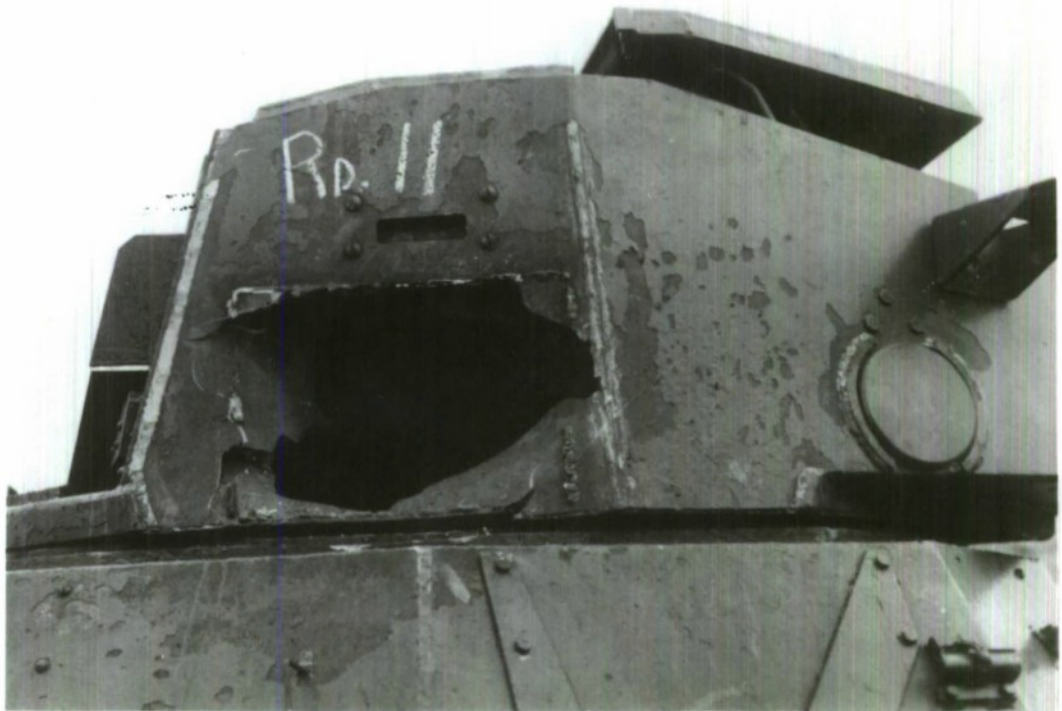
8. Three rounds were fired at the crew compartment with no success from the assessment aspect (Figures 9, 10 and 11). It had been hoped to simulate the APC crew compartment by up-armouring the plates on the car to about 1 inch thick (initially they were only 8 to 16 mm thick), but this could not be achieved. The car bodies were composed of a number of fairly small plates which did not provide sufficient support for the extra armour where the round struck. With each round the up-armouring weld did not hold on impact and the outer plate was driven through the main inner car plate and the round penetrated and detonated inside the car. Little useful information was obtained from these rounds other than confirmation that their effects in a confined space are more than adequate to immobilise the vehicle and incapacitate the crew.

10.	Repeat of 9 up-armoured to 26 mm.	Plate driven back through basic armour. Round detonated inside car. Unsatisfactory.
11.	Turret-side up-armoured to 35 mm armour/65° to normal.	Hole torn, up-armouring weld did not hold. Round burst in car. Unsatisfactory.

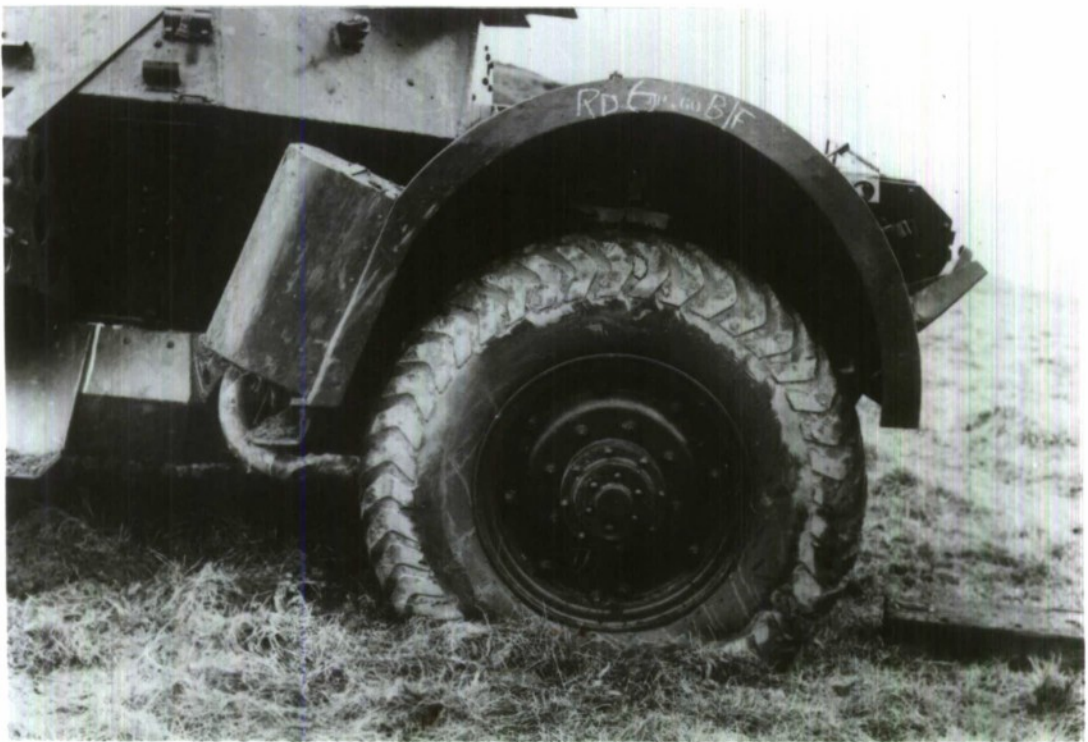
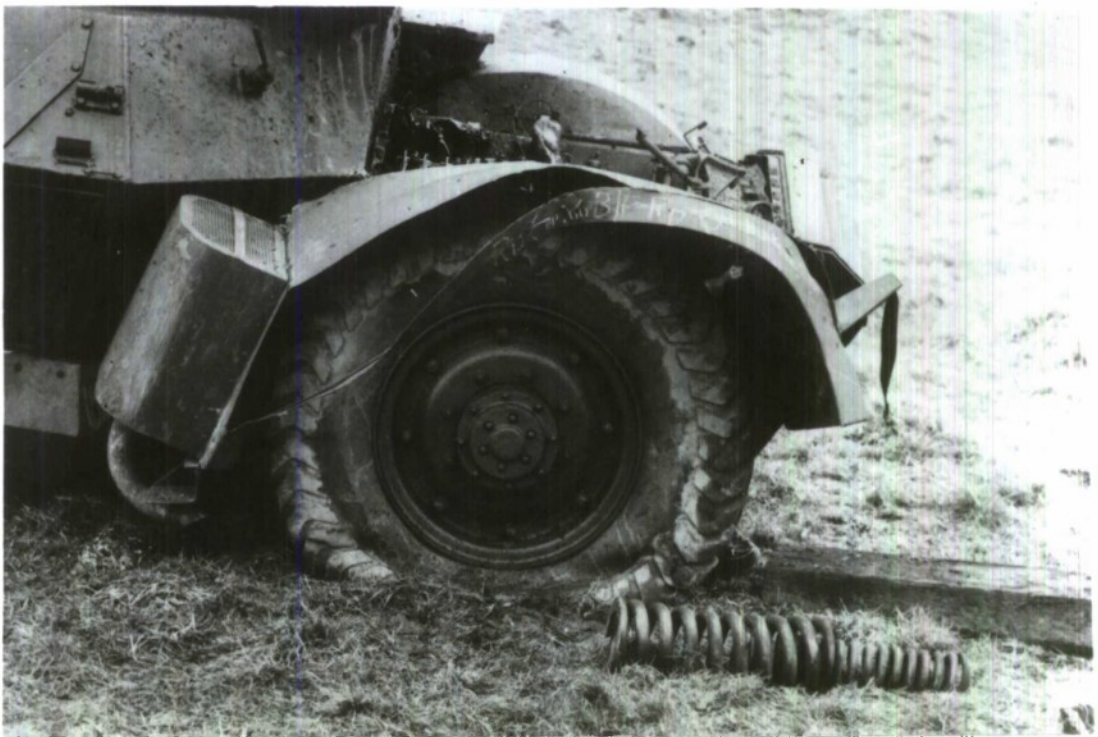
FIG. 12 DIRECT HIT ON SIDE OF ENGINE COMPARTMENT

- (a) Side of Engine Compartment (Figure 12). The round went through the 9 mm plate and detonated inside the compartment. The top cover was blown off and the engine severely damaged resulting in a complete loss of mobility.

12.	Engine compartment side (9 mm armour).	Round penetrated and detonated inside compartment. Engine severely damaged.
13.	Engine compartment rear (29 mm armour).	Up-armouring welds broke and round again detonated in engine compartment. Mobility loss = 100%

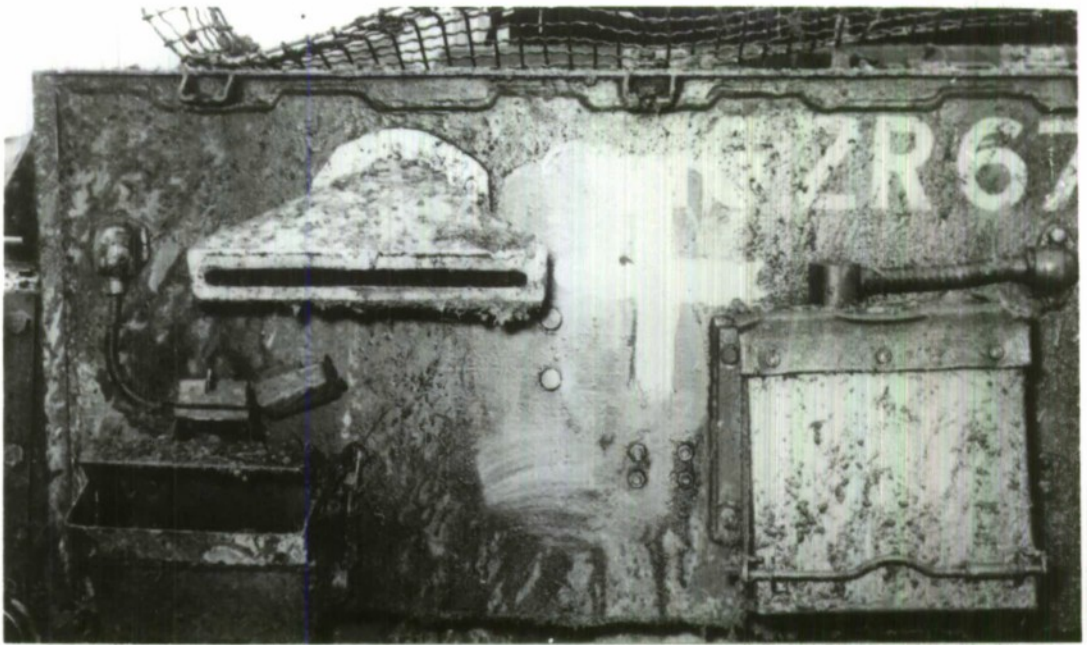
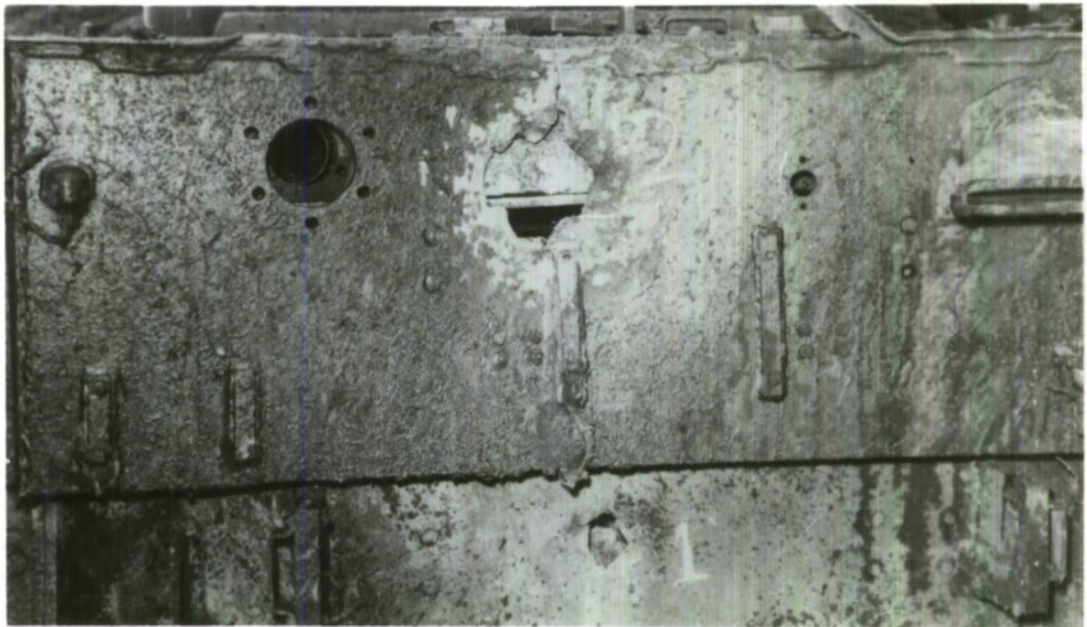
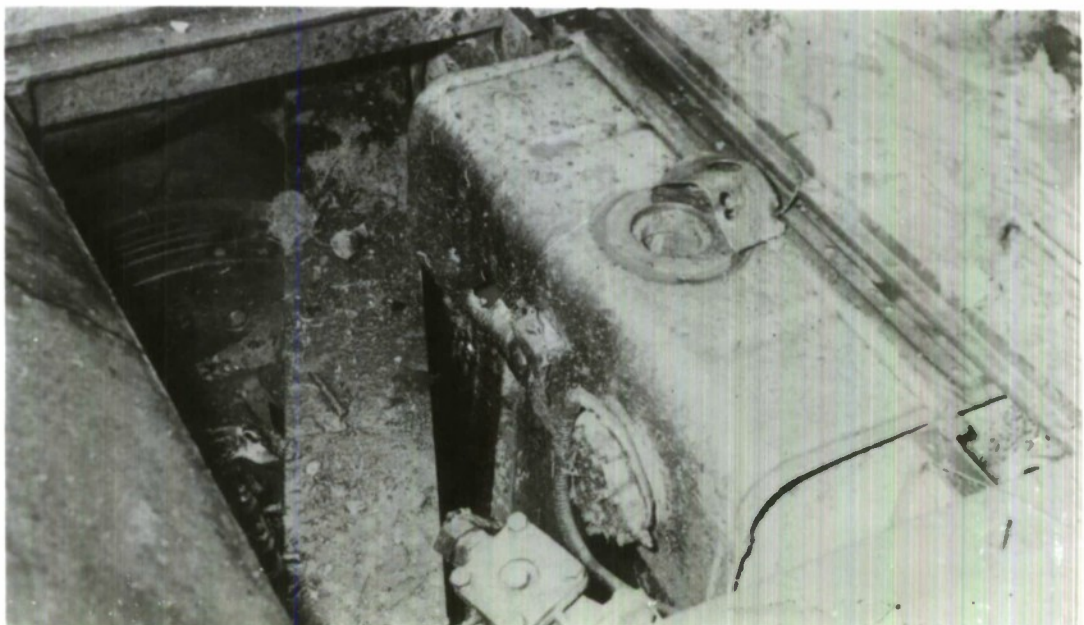
FIG. 15 DIRECT HIT ON REAR UPPER PLATE

- (b) Hull Rear Upper Plate. 25 mm/0° (Figure 15). The rear plate was holed and the resulting scab broken into fragments by a strut immediately behind the plate. The gearbox was destroyed and the coolant pipe and header tank holed. The loss in Mobility was 100% and there would have been a 10% reduction in Fire-power capability.

2.	Hull rear upper plate (25 mm/0°).	Plate holed, gearbox smashed, coolant pipe and header tank holed.	100	10	-
3.	Centre road wheel rim	Wheel severely damaged, two roller guides removed.	10	-	-

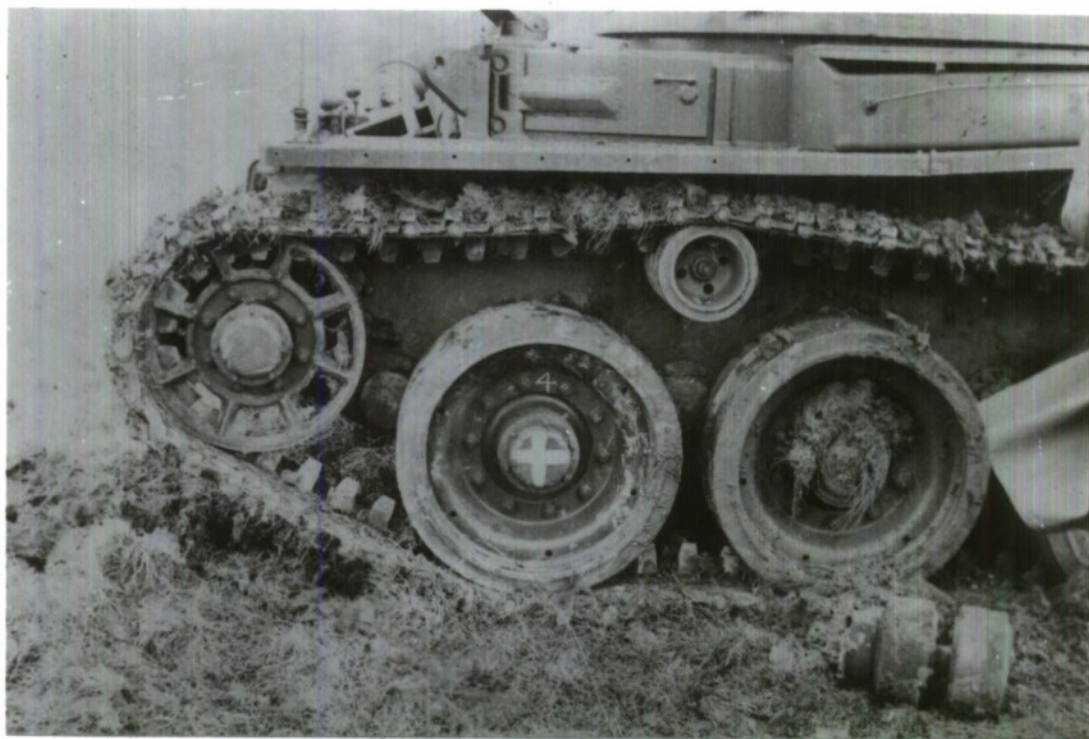
FIG. 17 DIRECT HIT ON FRONT ROAD WHEEL HUB

- (b) Front Road Wheel Hub (Figure 17). The wheel hub and rim were severely damaged but the tank was still capable of reduced movement.

Loss of Mobility = 15%.

4.	Front road wheel hub	Hub damaged but tank capable of reduced movement.	15	-	-
5.	Rear road wheel rim	Rim and hub severely damaged.	10	-	-
6.	Idler wheel hub	Idler severely damaged.	100	-	-

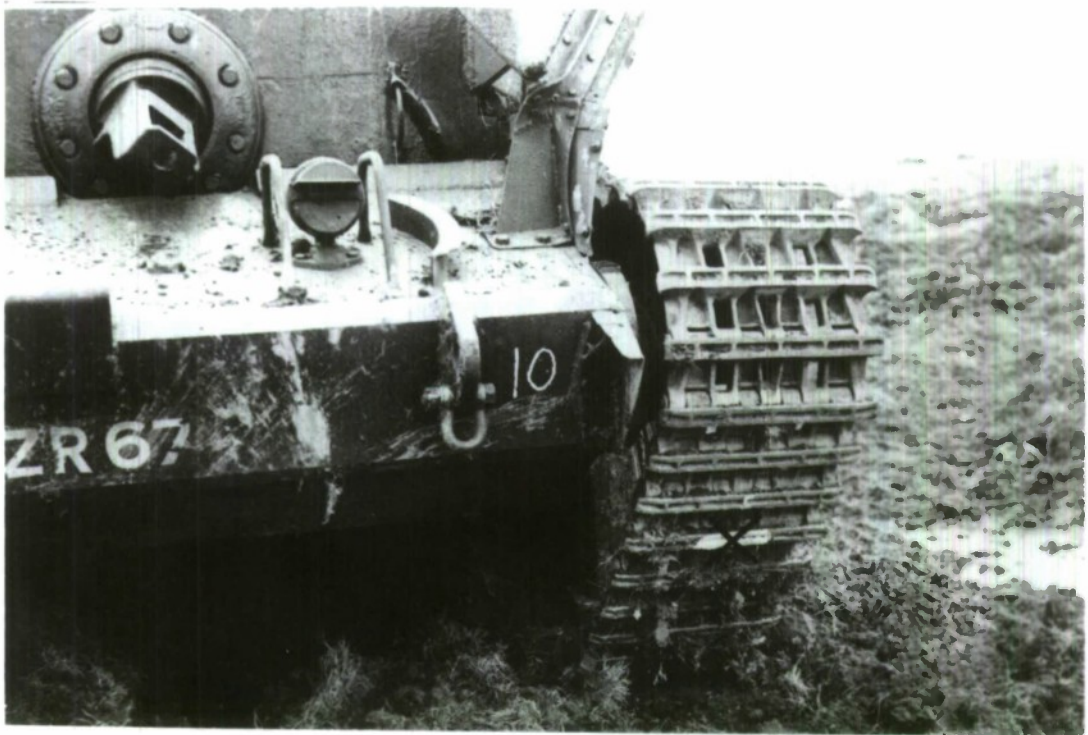
FIG. 23 DIRECT HIT ON LOWER TRACK

- (h) Track between Idler and Road Wheel (Figure 23). The round hit the track at 45° to its plane and completely cut it, removing the idler at the same time.

Loss of Mobility = 100%.

10.	Track between idler and road wheel.	Track severed. Idler removed.	100	-	-
11.	Mantlet (102 mm/0°)	Little mechanical effect. Driver and loader probably affected by blast.	80	50	-

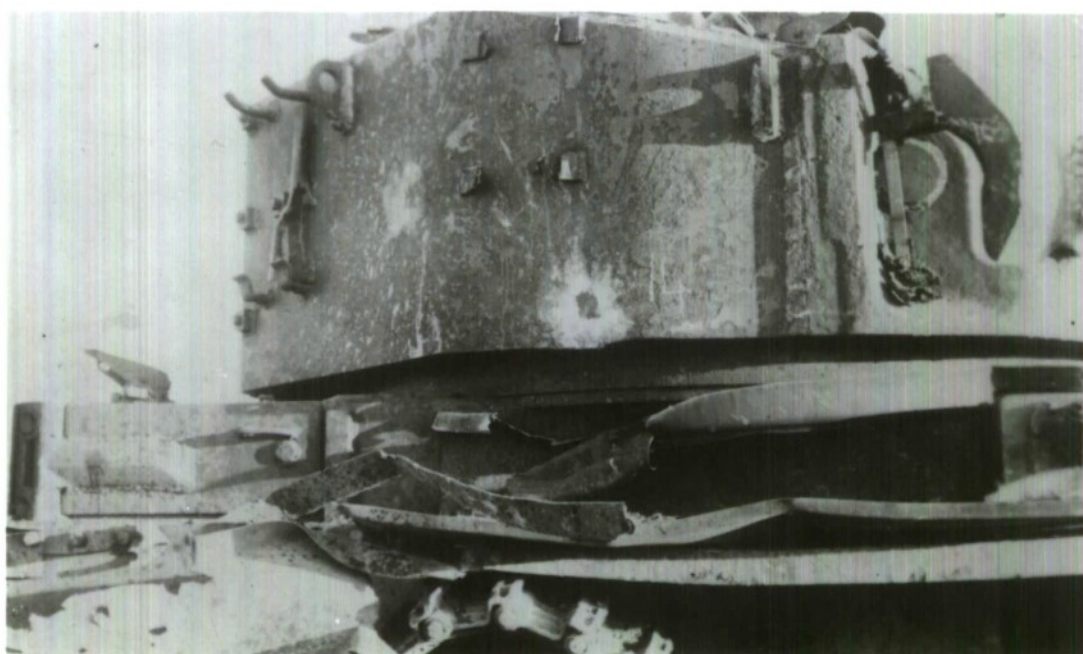
FIG. 25 DIRECT HIT ON PLATE OVER TURRET RING

14. In discussions on anti-tank projectile lethality, there have been differences of opinion regarding the effect of a nearby hit on the turret traversing mechanism of a tank. Since at the end of the present trial there was spare ammunition and a suitable target available, it was decided to investigate this question and several others on which information was lacking. Accordingly a round was fired at the plate skirting the turret ring of the Comet tank (Figure 25). On examination of the turret interior, it was found that the plate had scabbed and that damage to the dummies placed in the turret to simulate crew members showed that the turret crew would have been incapacitated. Damage to the gun and associated equipment from blast and the scab had made it unserviceable. The resulting loss in Mobility was 65% and in fire power 100%. Regarding the mechanical condition of the tank, it is worth recording that the hand-traversing mechanism of the turret was still in working order although a little stiffer than before the attack.

12.	Turret skirt (64mm/0°)	Turret armour scabbed. Gun U/S. Turret crew incapacitated. Traverse mechanism O.K.	65	100	-
13.	Turret stowage bin (Empty) (57 mm/0°)	Turret armour scabbed. Turret crew incapacitated.	65	100	-
